Ten-Tec Argonaut V (Model 516) Low Output Repair

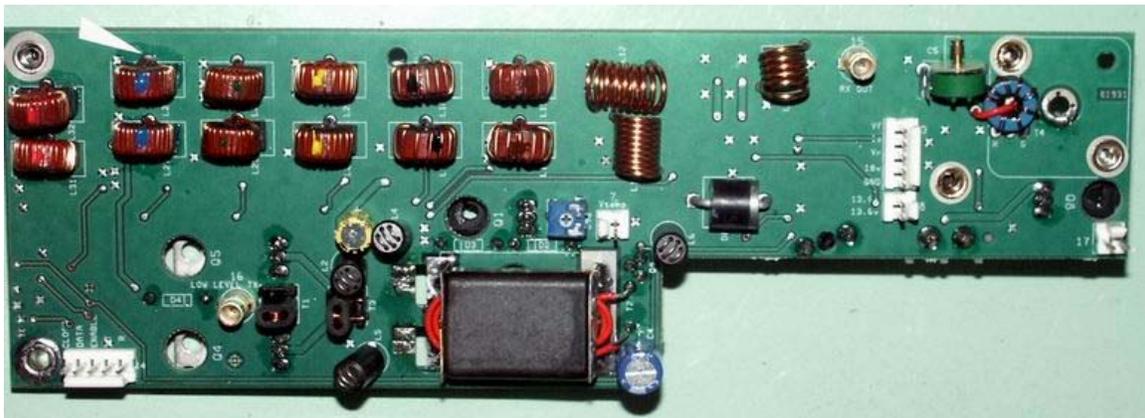
Figure 1: Test points (PA board removed from rig)

With the top off of the rig you can access all the necessary test locations to determine if the band switch circuitry is functioning properly (*use caution*). A series of coils are located on the circuit board (see figure 1) that is attached to the heat sink. These coils are a part of the various band-switching stages and are connected to the **Bandout** rail. They are identified as 160 metres (L32) at the left, L28, L24, L21, L18, L15 and end with the 15 through 10 metre coil (L12) at the right. (The latter coil is air wound all others are wound on ferrite cores.)

top of the PC board (see arrow on 80 metre coil). The measurement is made with the rig in key down CW at full power into a dummy load. All coils should have approximately -150 volts **except** the selected band, which should read approximately +8 volts. Check all bands and all coils.

In my tests the voltages when the rig was on 80 metres were correct. That is +8 volts on the 80 metre coil and -150 on all other coils. However, when other bands were selected the voltages were quite different. For example, when 40 metres was selected there was +8 volts on the 40 metre coil, +6 volts on the 80 metre coil and -75 volts on all the others (see table below). This suggested that the 80 metre circuitry was turned on at all times - likely the result of a shorted switching diode or faulty transistor feeding the diodes.

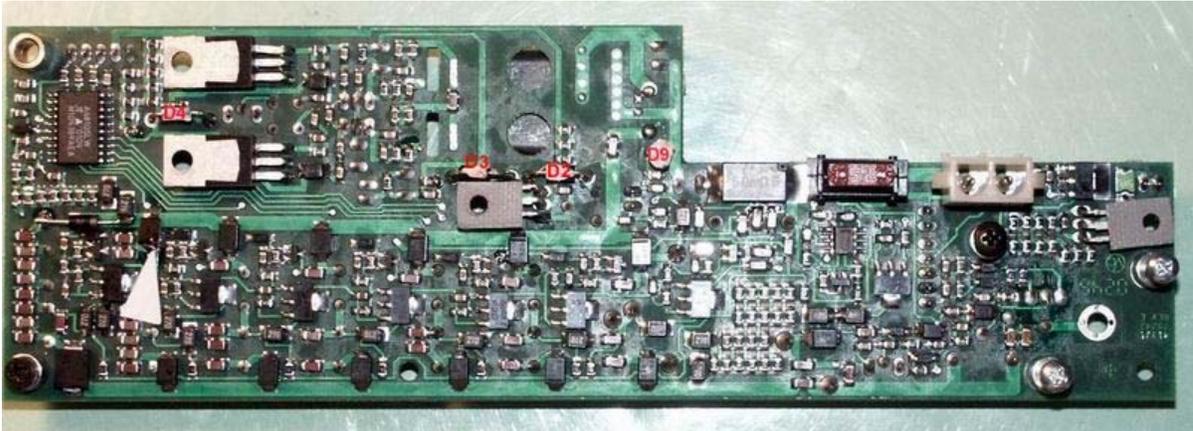
Figure 4: Diode side of PA/LP Filter Board

16. Test the diodes with a DVM. A faulty diode will have a resistance of 100 or 200 ohms or less. The board with the offending 80 metre diode, marked with a white arrow, is shown in the figure 4.

17. Carefully note the polarity and then unsolder and lift the faulty diode. Test it again to be sure!
18. Replace the faulty diode with a new 1N4007 or surface mount equivalent (ensure that the polarity is correct) and recheck all the diode resistances. They should be similar. (If they are not similar, the problem **may** be the transistor feeding the switching diodes and the transistor will need to be tested and, if faulty, replaced.)
19. Re-assemble the radio in reverse order. (**Note:** Do not forget to apply heat sink compound to D2, D3, D4 and D9 – see red identification in figure above.)
20. Test the Argonaut into a dummy load and reinstall it back into service.
