Ten-Tec 253 Automatic Antenna Coupler Intermittent Keying Loop

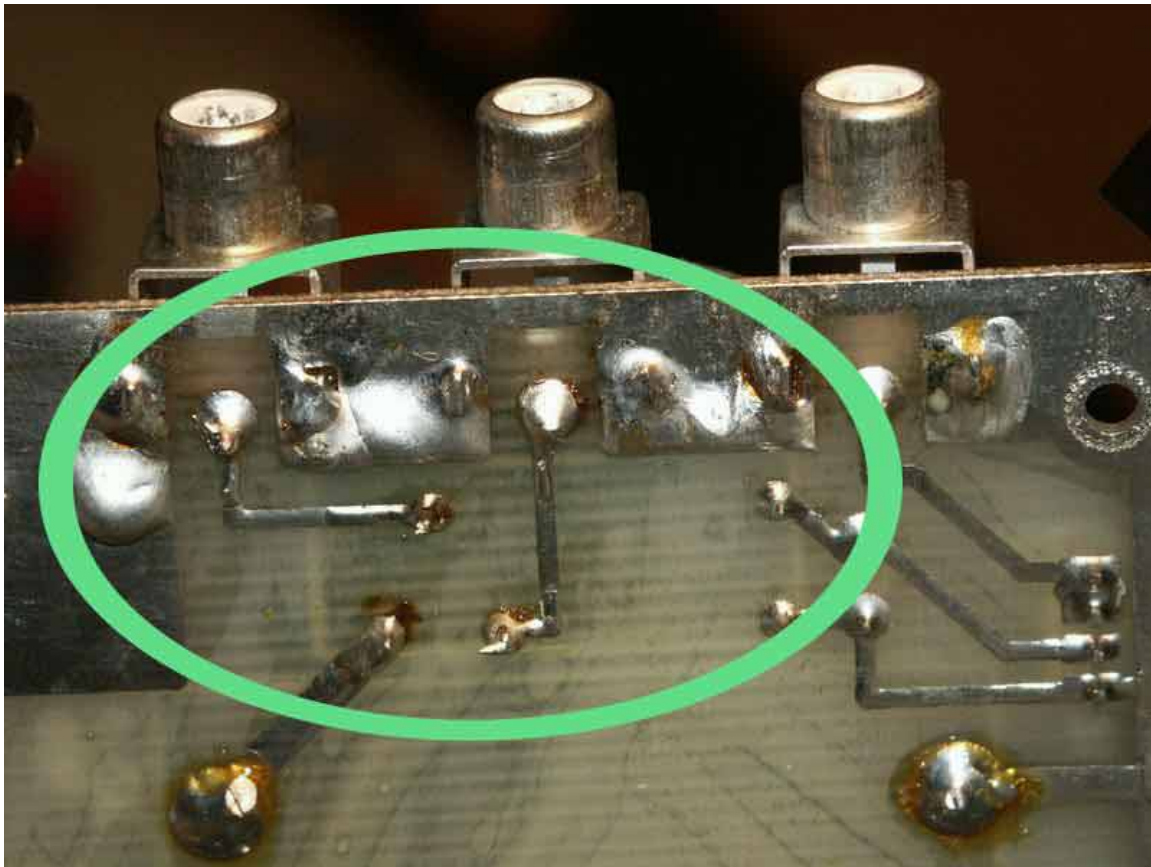
The problem went away. Then after a few weeks it reappeared. It seemed to reappear whenever I got near the T-T 253 **Exciter Out** or **Exciter In** RCA connectors.

I looked over the **KW Bridge Pad Board** schematic (Figure 4-7) and it was obvious that my problem involved the RCA jacks and/or relay K6.

I removed the 253 case, SO-239 for the RF Input, all plug-in connections (32, 31, 22, 21, 12 and 29) and the 4 screws holding the board in place. With some inter-board RF cables still soldered in place, I was able to manoeuvre the board and examine the **Exciter** RCA jacks.

The connections didn't look that bad BUT I resoldered the jacks and the relay contacts.

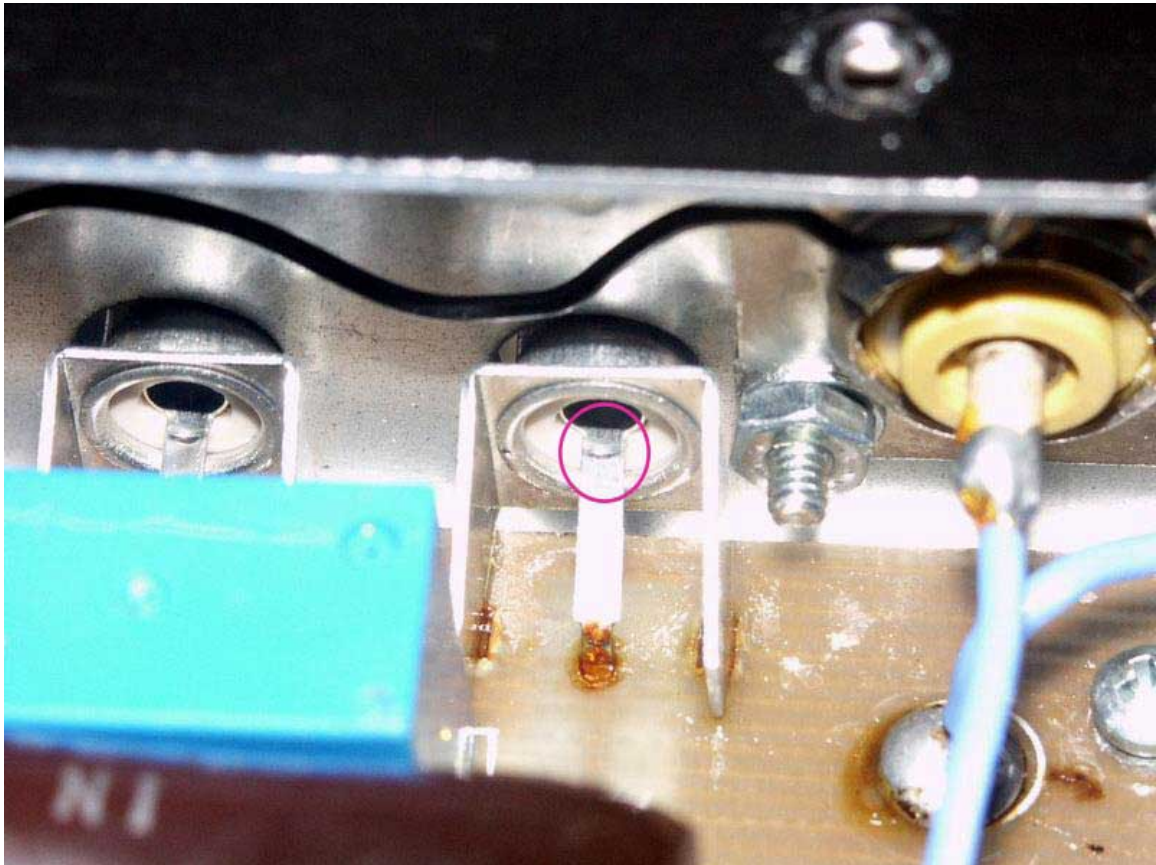
As I was reassembling the 253 I inserted RCA plugs in the sockets and measured the resistance. All was well BUT the plugs felt *sloppy*. To resolve this issue (it may have been the main culprit) I built up the inner contact of both the RCA jacks with some solder (See the circled area in the figure below) to make the connection somewhat more secure. (**Note:** There's a fine line between more secure and blocking the jack so be sure to test the fit prior to buttoning up the 253.)

I put the T-T 253 back into service and it has run flawlessly since. A simple fix but an annoying problem seems to have been solved.
